Historic Structure Report

**THE ADMINISTRATION BUILDING
(THE RYAN CENTER)**

**Gateway National Recreation Area
Floyd Bennett Field Unit**

By
Judith A. Quinn

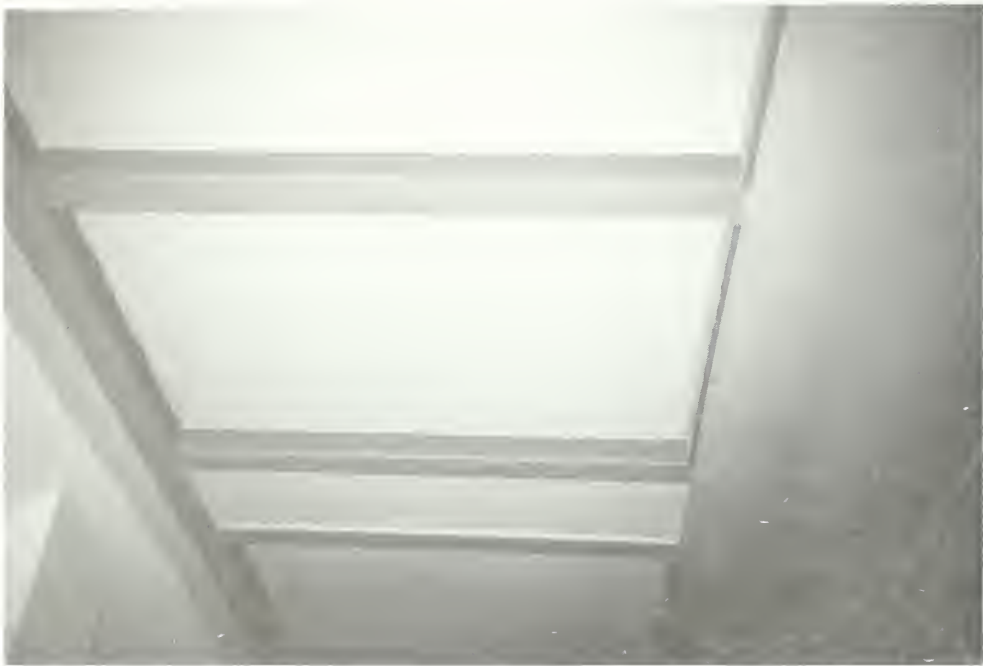
Figure 29. North corridor, east wall: former window wall looking into Room 110, plate glass now replaced with plywood.

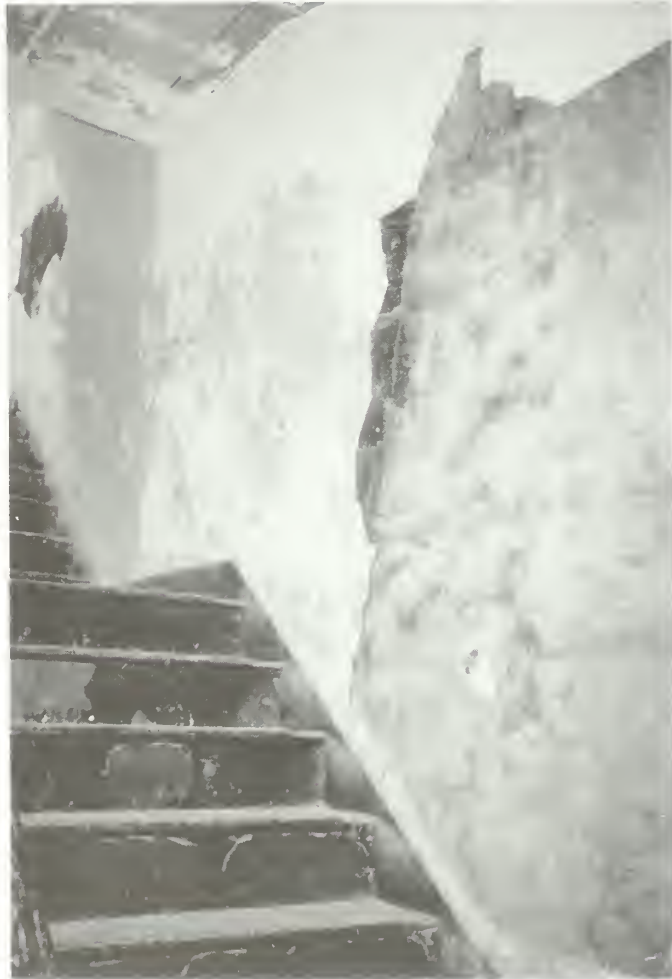
Figure 46. Imitation Caen stone on wall of Stairway #5 between second and third floors, showing pargeting spalling from scored cement brown coat.

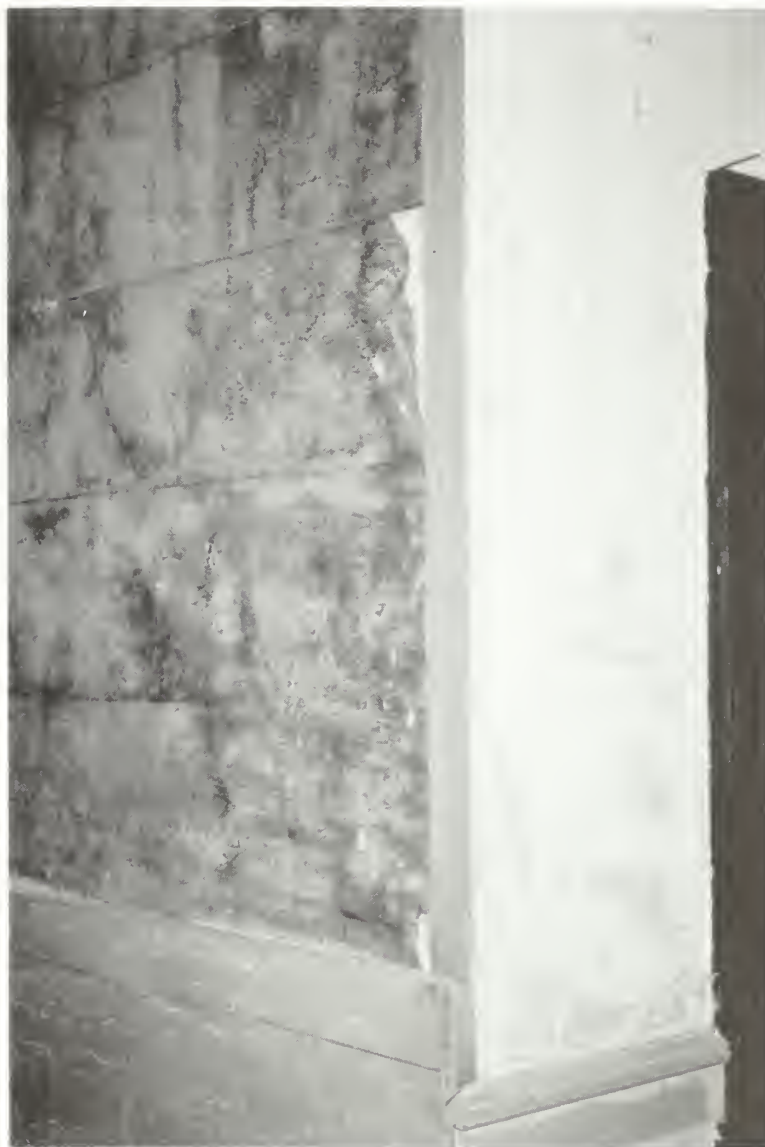
Figure 47. Imitation Caen stone at juncture of wall of Stairway #5 and east wall of south corridor, second floor. Exposed cement brown coat of imitation stone on left, scored plaster on right.
